TAMIL NADU GENERATION AND DISTRIBUTION CORPORATION LIMITED

Sub: Electricity – Tirupur EDC– Methods adopted in reducing the Fault Trip on Distribution Feeders -submission–Reg.

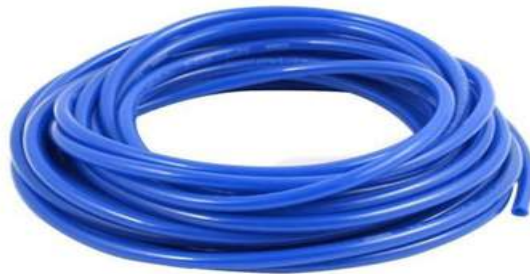
- 1) Bird faults are happening mostly where the HT lines are passing through areas like dumped with Garbage, Food wastage, Poultry and Slaughterhouse wastes. It was observed that the Faults are occurred while the birds are climbing up with the food waste and touch between the lines and electrocuted causing HT feeder to trip. In order to avoid such happenings it was decided to increase the gap between the conductors by using 5.0 ft cross arms (from 3.5 ft) and providing the top middle conductor with compressor air hose pipes as insulation.

Compressor air hose

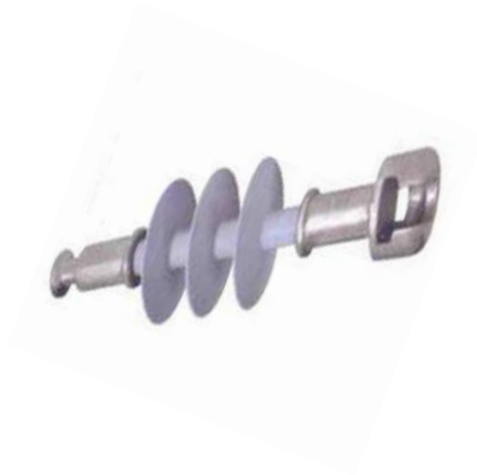
- 2) By increasing the creepage distance at the pin point and cut point in the fault prone areas by replacement of conventional porcelain discs by polymer disc which has avoided short circuits with ground by birds, squirrels, cat etc. As the surfaces of the polymer insulators are flexible and highly inconvenient to sit or move along the surface for them. This method has been implemented and so far no further faults have been noticed so far.

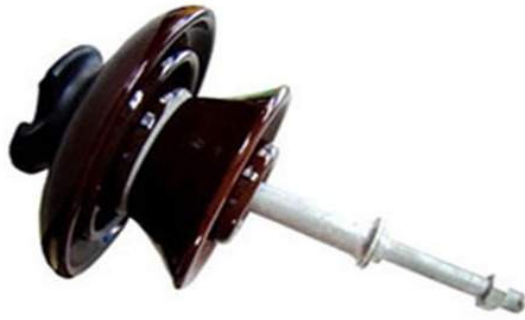
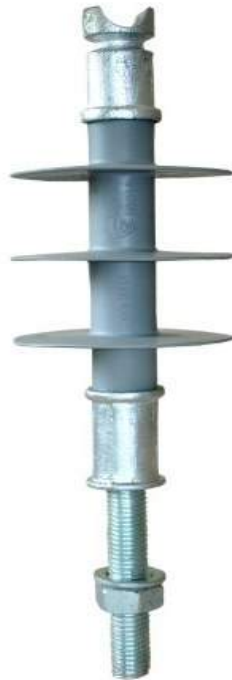
3) Replacement of conventional pin insulator with Polymer pin insulator

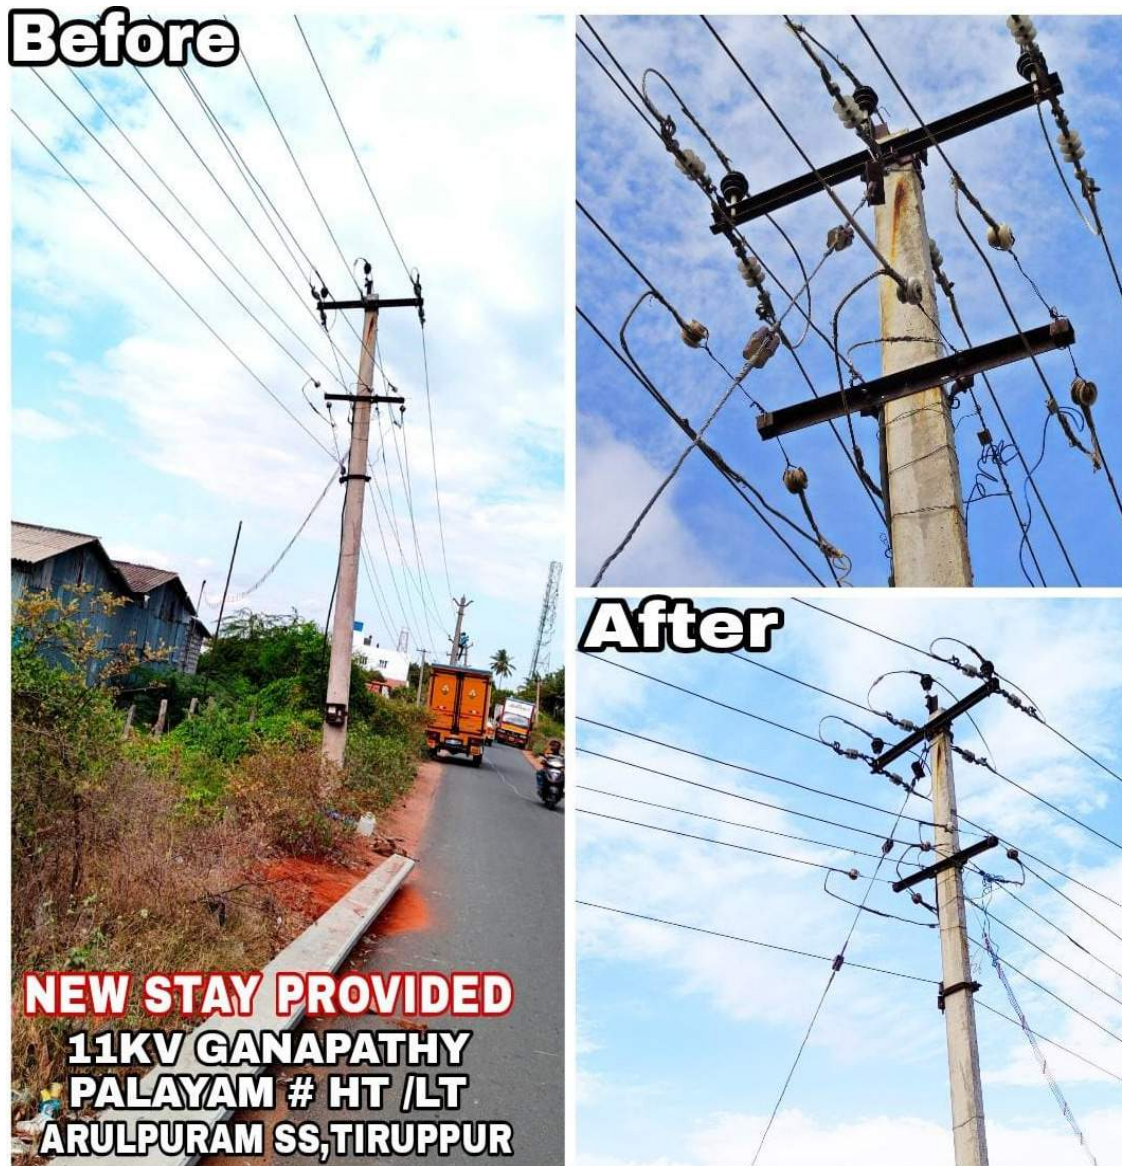
- 4) In certain places the loose stay came in contact with the live wire during heavy winds causing fault trips on earth fault since the stay clamps and metal parts on the poles are earthed. In order to avoid such type of faults in future the stay wire was tightened and placed two stay insulator one at the top and another below the lowest conductor to avoid fault trip (EL) due to accidental contact of live wire and result in no visible fault.

Stay provided below lowest conductor in 11KV Ganapathipalayam feeder of 110/11KV Arulpuram SS in Tirupur Circle

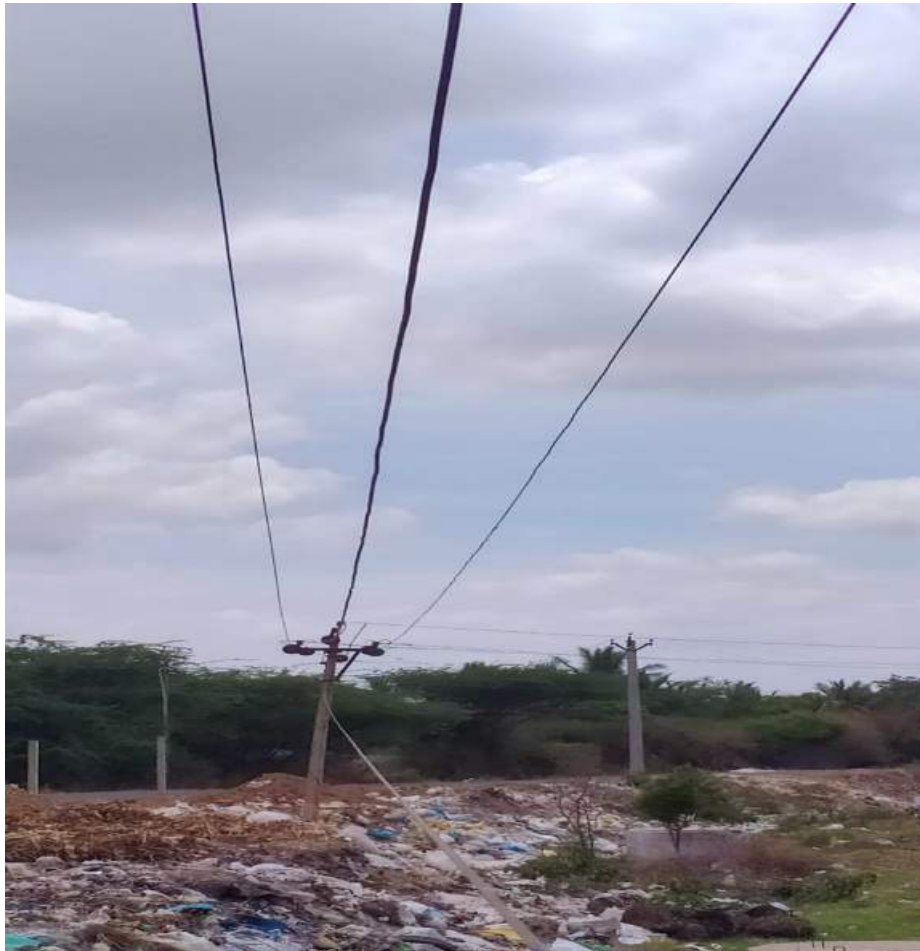
Middle phase insulated to prevent bird fault in Tirupur Circle
