TAMIL NADU GENERATION AND DISTRIBUTION CORPORATION LIMITED

Sub: Electricity – Tirupur EDC– Methods adopted in reducing the Fault Trip on Distribution Feeders -submission–Reg.

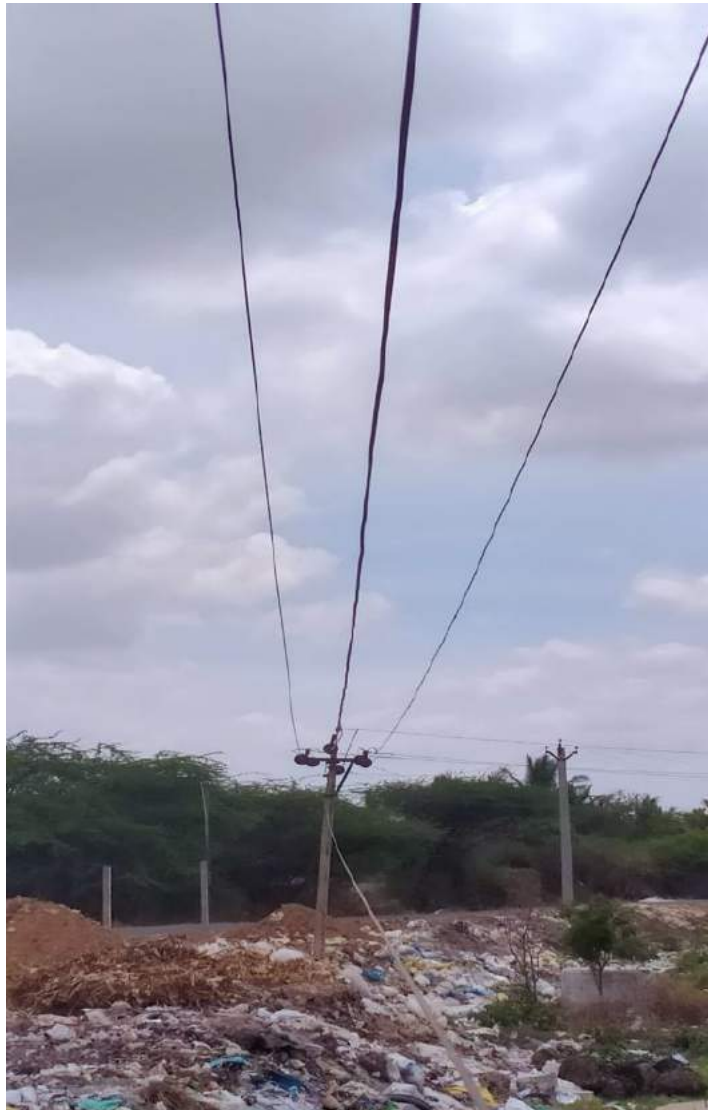
- 1) Bird faults are happening mostly where the HT lines are passing through areas like dumped with Garbage, Food wastage, Poultry and Slaughterhouse wastes. It was observed that the Faults are occurred while the birds are climbing up with the food waste and touch between the lines and electrocuted causing HT feeder to trip. In order to avoid such happenings it was decided to increase the gap between the conductors by using 5.0 ft cross arms (from 3.5 ft) and providing the top middle conductor with compressor air hose pipes as insulation.

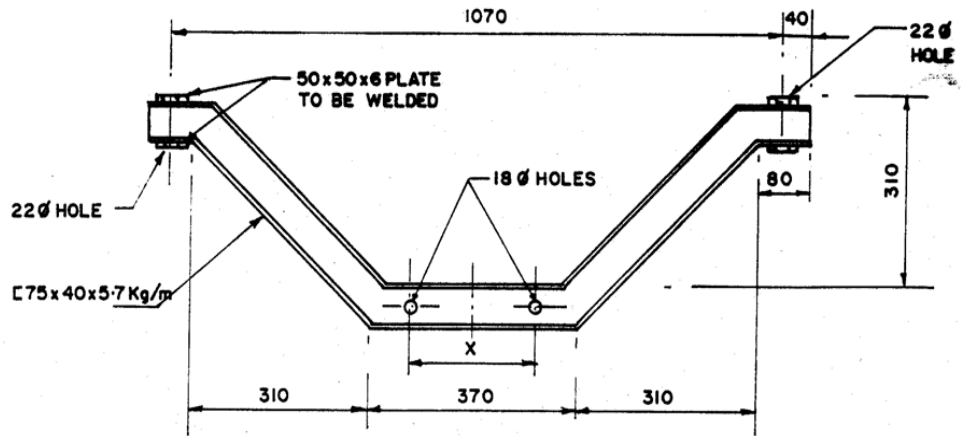
CONSTRUCTION STANDARD
A-6

33 KV V-CROSS ARMS WITH POLE TOP BRACKET & BACK CLAMPS FOR SINGLE POLE
Cat. No.- CCSP-33

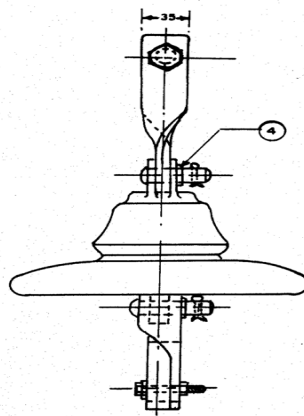
CONSTRUCTION STANDARD
C-2

- 2) By increasing the creepage distance at the pin point and cut point in the fault prone areas by replacement of conventional porcelain discs by polymer disc which has avoided short circuits with ground by birds, squirrels, cat etc. As the surfaces of the polymer insulators are flexible and highly inconvenient to sit or move along the surface for them. This method has been implemented and so far no further faults have been noticed so far.
